Project: Thomas Brooks Park

Subject: Slave wall assessment by Restoration Masons

This memo outlines the present wall conditions and treatment plan for the historic slave wall at the Thomas Brooks Park project as directed by Richard Irons of Restoration Masons.

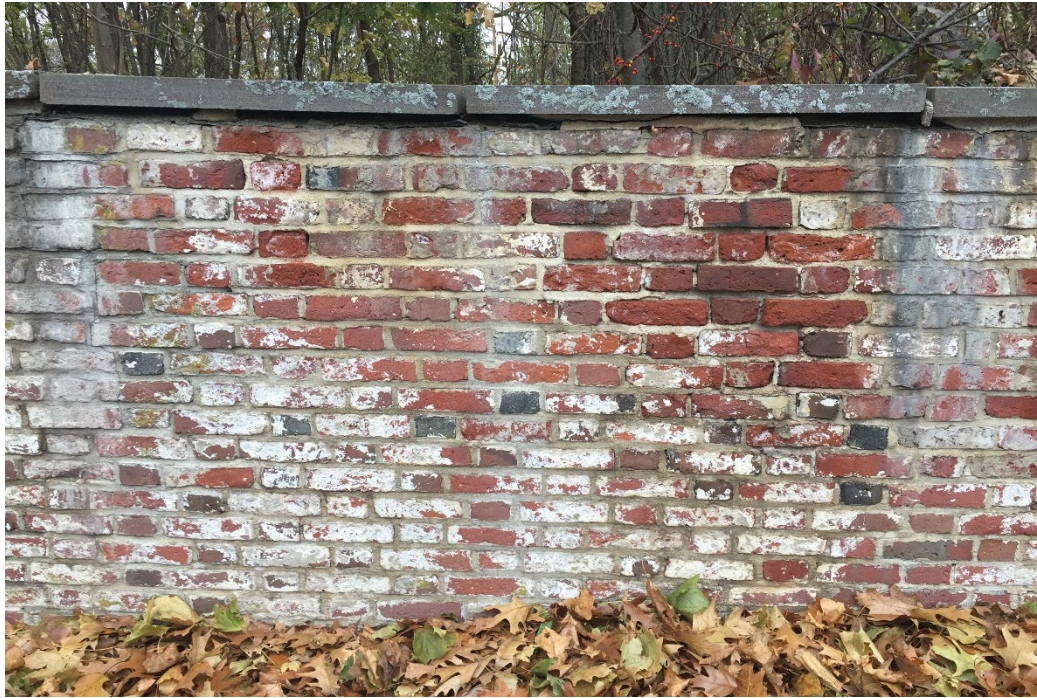
- The wall was composed of 3 courses of 4" wide brick courses for an approximate 12" deep wall laid in Flemish Bond (every other brick a "header") turned 90 degrees and interlocked with the course behind it (Figure 1).

Figure 1. Typical wall condition mid-wall.

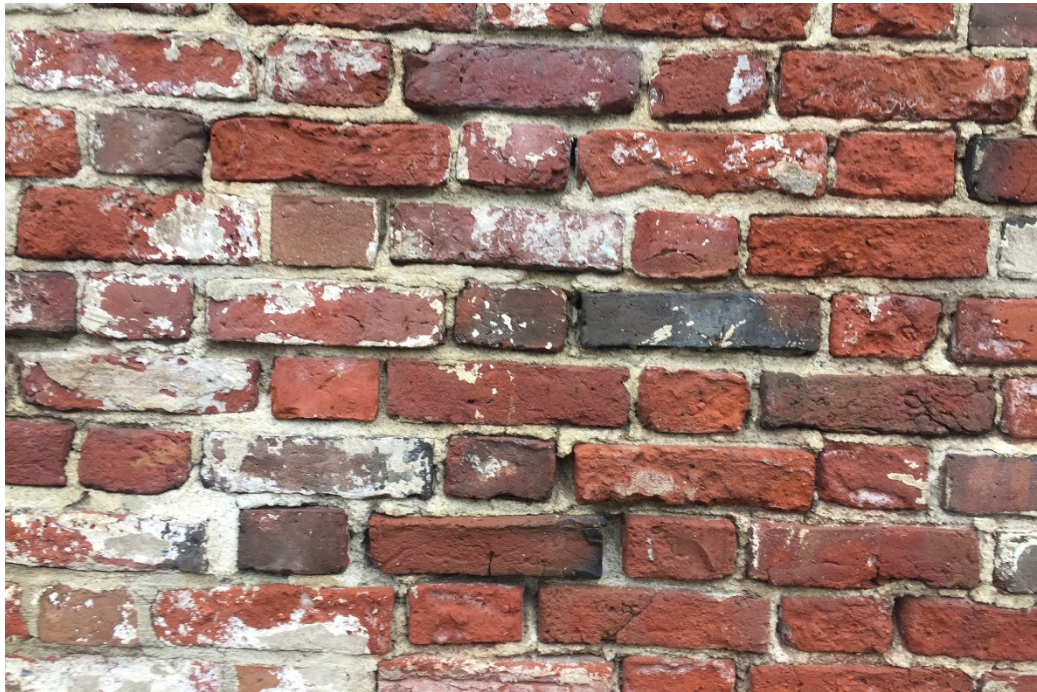
- A limited sample of original work exists mid-wall, with eroded bricks and eroded lime mortar joints (Figure 2).
- The wall is 76'7" long, 4' above grade on the north side and 3' above grade on the south side.

Figure 2. Presumed original wall brick work, with eroded bricks and eroded lime mortar joints.

Issue: All open joints need to be closed, loose bricks relayed and repointed with proper matching materials.

- Cap Stone Option 1 – At a minimum – fill cap stone joints with 3.5 hydraulic lime mortar mix, reset loose stones with the same.
- Cap Stone Option 2 – Remove all cap stones, install metal flashing over wall, pin and reset cap stones (with lead).
- Repointing (needed with either Option 1 or Option 2): Repoint all open joints in brickwork with lime mortar. Proper prep / clean and wash. Re-lay bricks in loose areas (where bricks move with tapping or joints eroded past 1.5" depth).

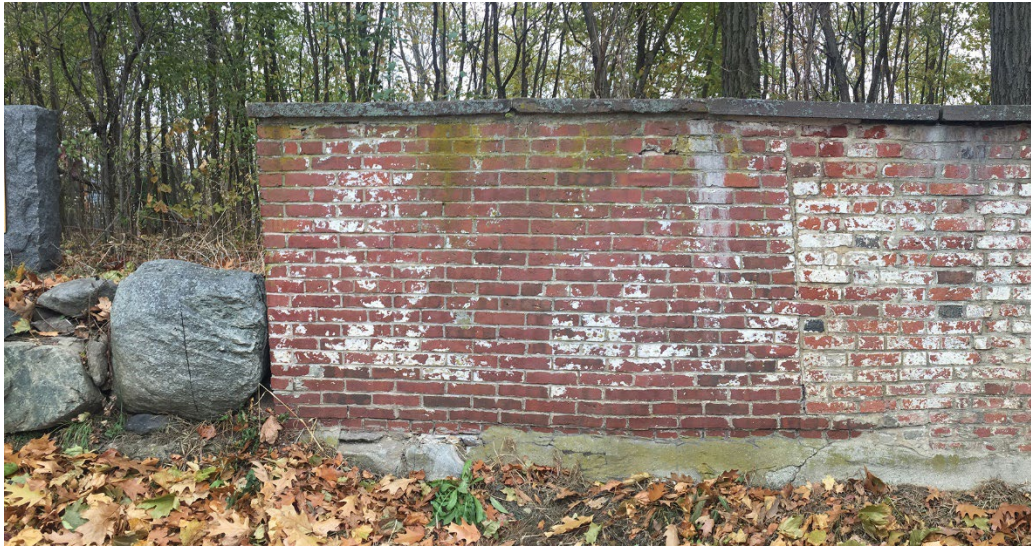
- At the south end of the wall there is 8" of wall or 3 brick courses below grade (Figure 6).
- The first 6-7' of the north end of the wall was added late in the nineteenth century. It is laid in straight running bond, not integrally tied together with the other courses (Figure 3).

Figure 3. North end of wall – presumably added late 19th century – with vertical joint separation.

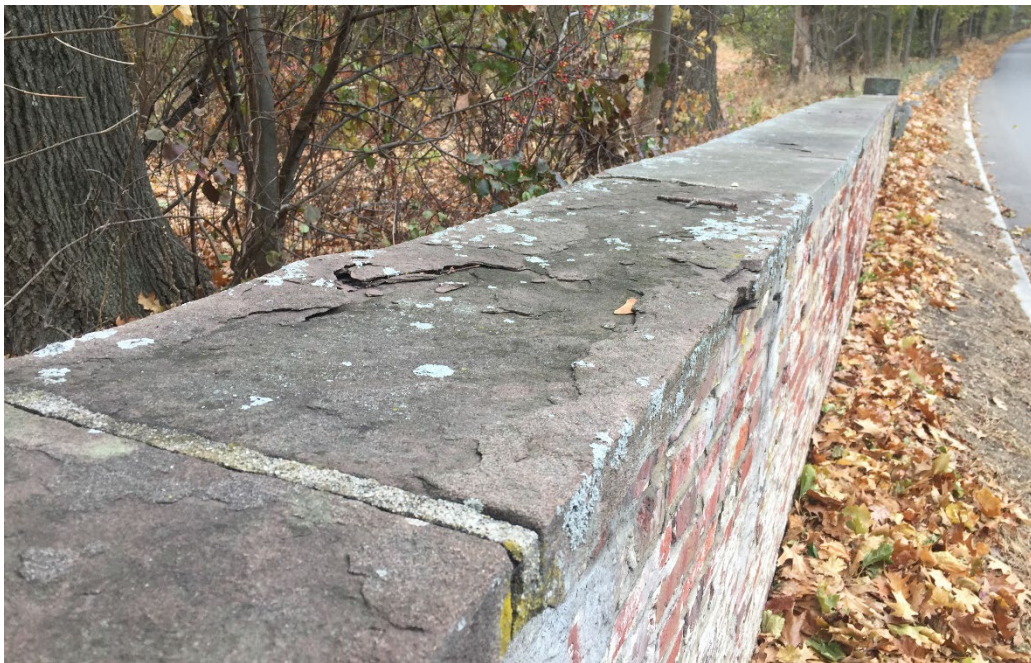
- The existing wall footing is flat stone bedded on stable soil. The northern end of the footing is stuccoed over with Portland based mortar.
- The wall is capped by bluestone or brownstone in random lengths, some are older and presumably 50+ years old. The cap sections average 30" long and 14" wide, properly overhanging the brick 1" on the sides (Figure 4).

- Mortar joints between cap stones are missing or in poor condition. There is some evidence of flashing (copper, lead or tin) under edges of stones (not the whole top of the wall).

Figure 4. Bluestone or brownstone wall cap.

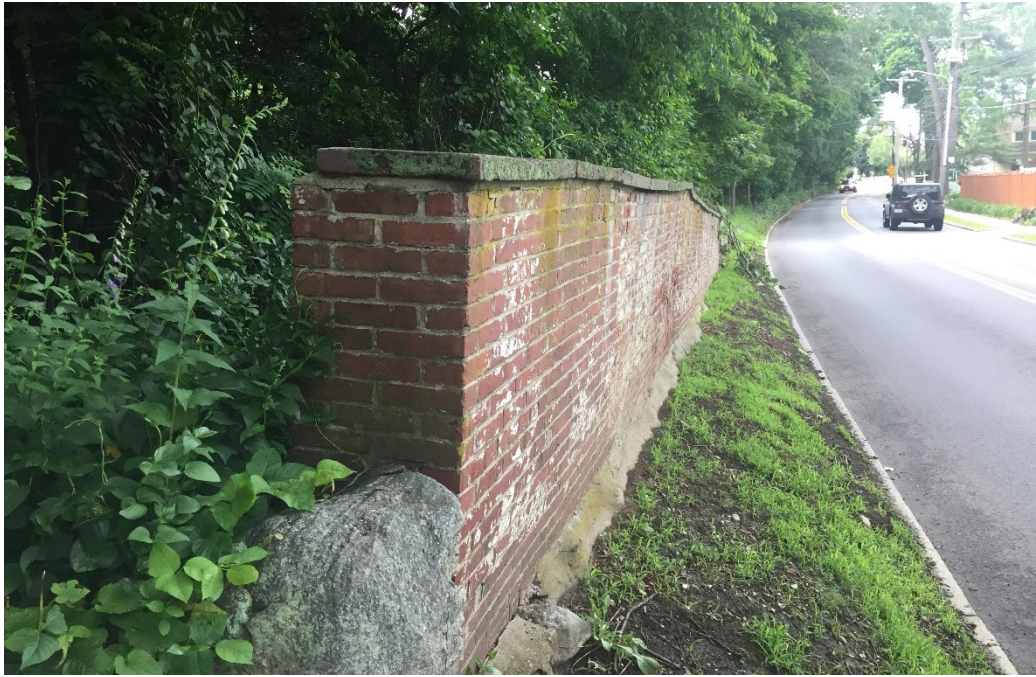
- The wall is out of plumb 4" in 4' on the north end (which is significant) leaning towards the road (Figure 5).

A key issue is if the existing wall is stable and secure or still moving. The wall needs to be monitored and documented yearly. An increase of tilting forward by 1/4" per year on the north end of the wall would be significant (but this is not expected). Movement could be caused by road expansion, freeze/thaw pushing footing base in on the west face, less soil backup on north end, and traffic vibration. The wall is still very intact to itself.

Figure 5. North end of wall – out of plumb and leaning towards road.

Solution: Add more soil up over the foundation stones on the north end, compact, and cover these brick courses similar to the south end of the wall. Plant groundcover vegetation on the pitched soil away from wall (west side) to slow water runoff and minimize erosion on the road side.

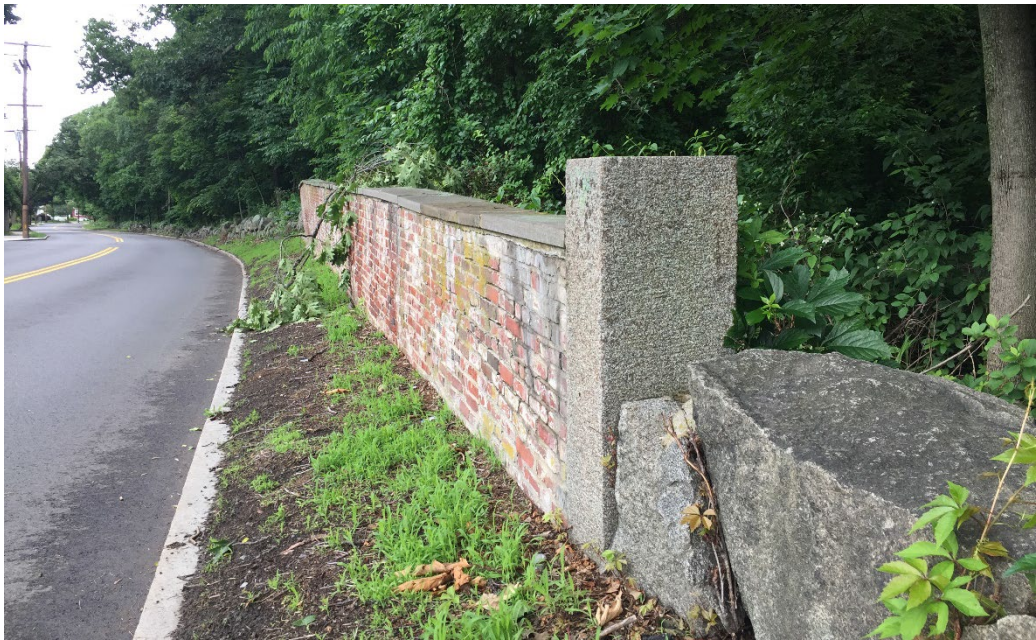
- The middle of the wall (30'-50' in from the north end) improves to being out of plumb 2" in 4' and improves to almost plumb at the south end (Figure 6).
- The wall is still intact, however, and has not shifted apart vertically.

Figure 6. South end of wall – nearly plumb – with soil built up against wall footer.
