## FORM A - AREA

**Town/City:** Medford

**Name of Area:** Cotting Street

**Date :** March, 2014

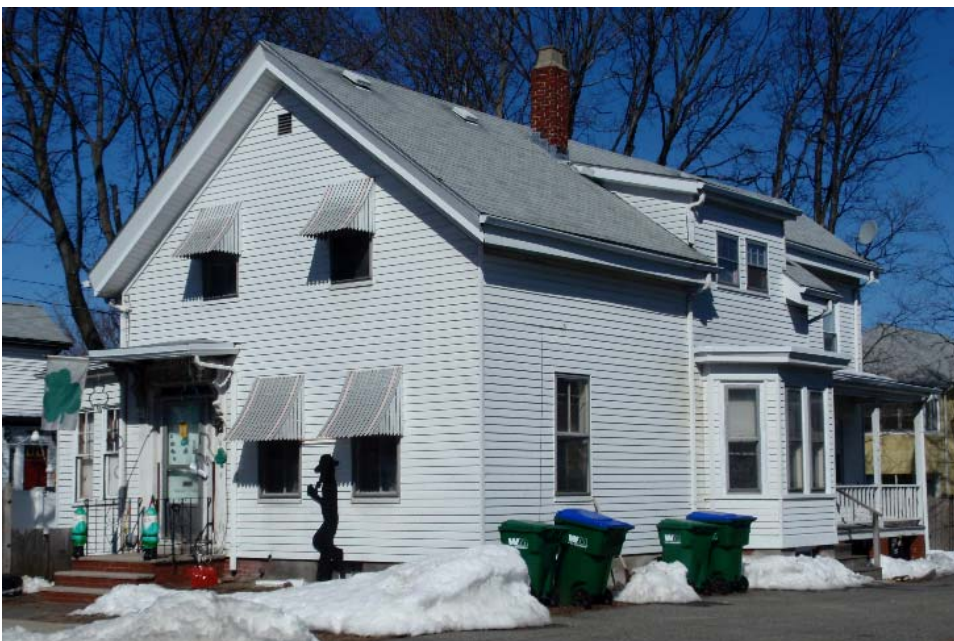
15 Coting Street, very similar to 21 and 27 Coting Street

At the **Tyler house, 15 Coting Street** (by 1855), the entrance is in the west bay of the main façade, and although the house has been covered in vinyl siding and had its trim removed, a flat hood over the door is supported by two elaborate brackets with drop finials and a row of dentils is visible under the hood above the door; it sits on a brick foundation and is topped by an asphalt roof. On the west elevation of the house is a single-story, two-room addition with a flat roof. A large gambrel roof dormer with two windows sits in the west slope of the roof, taking up its middle third. A brick chimney exits the roof just to the north of this dormer. The east elevation of the house has had several changes: in its center is a single-story polygonal bay with a flat roof. Above this is a shed-roof dormer that sits at the edge of the main roof. A chimney exits the roof halfway down the east façade, in front of the shed dormer. To the north of this bay and dormer is a jog, recessing the east elevation of the ell; this section of the house has been raised to two full stories and single-story flat-roof open porch fills in the recessed area. Several two-over-two windows that are protected by exterior storm windows and metal awnings cover the four windows on the main façade of the house. The house is roughly centered on its lot, and a driveway that leads to a small 1920s-1930s two-car garage the east side of the lot, constructed of rough-faced cast-concrete with a hip roof; the west side of the lot has several mature trees.

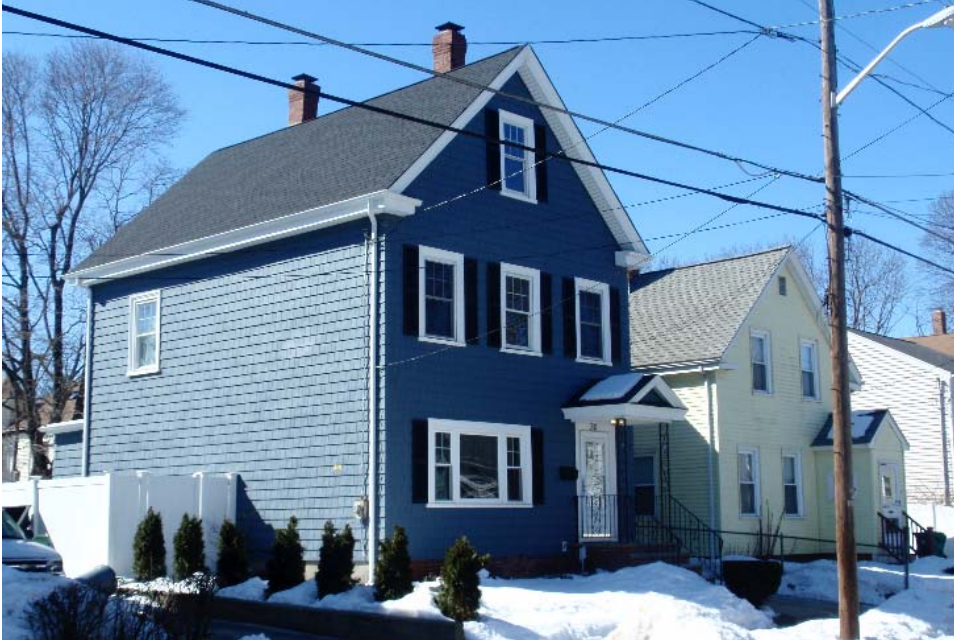
20 and 22 Coting Street

A final one-and-a-half story end house, **22 Cotting Street**, first appears on maps in 1900, sharing a lot with **20 Cotting Street**, across the street from other houses of this type. The building has its entrance in the west bay of the front façade and an enclosed projecting gabled entry porch, accessed by a short set of stairs, covers the entry door. On the west façade, towards the rear, is a shallow single-story rectangular bay with a flat roof. This example does not have a rear ell, but instead likely employs a version of the four-square plan, consistent with its later date. A chimney exits the house just to the east of the ridgeline in the center of the building. The house has vinyl siding, replacement one-over-one sash windows, and an asphalt shingle roof. A driveway is located on the west side of the lot.

At the **Parker house, 20 Cotting Street**, constructed between 1855 and 1875, the main entrance is also in the west bay, and a small gable roof supported by two wrought-iron columns covers the entrance, which is accessed by a set of brick stairs with wrought-iron handrails. The two windows to the east of the entrance have been replaced by a picture window and two narrow four-over-one sash. There is a gabled bay on the west elevation of the house toward the rear. Just in front of this is a one-window shed dormer. The house is covered in vinyl shingles with vinyl shutters, the vinyl windows have muntins to give them a six-over-one sash appearance, and there is an asphalt shingle roof. Two evenly-spaced chimneys exit the house at the ridgeline. Like its neighbors it sits towards the front of the lot on the south side of the street, with a driveway to the rear along the west side of the lot. Enough room was left at the rear of the lot for a modern in-ground pool.

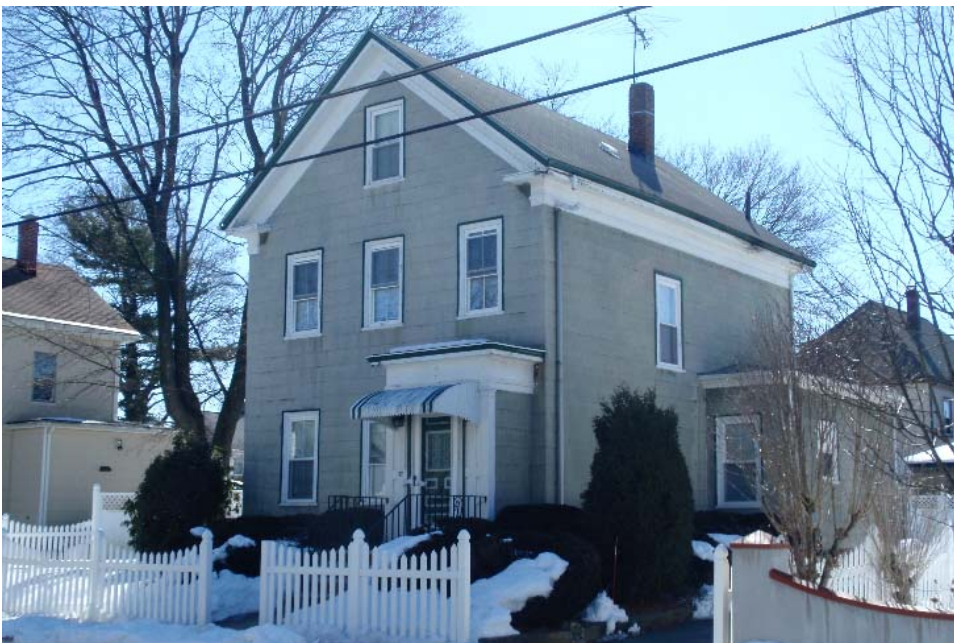
32 Coting Street, a common form in the neighborhood

Probably the best preserved example in the group is the Italianate house at **32 Coting Street**, which first appears on a historic map in 1889 but which has some trim that suggests a later updating. The house is covered in asbestos shingles, but large frieze boards on the sides of the house and deep cornice returns on the gable ends were maintained. The main side entrance is in the west bay of the main façade, covered by an enclosed, projecting, flat-roof entry porch with a metal awning. It is trimmed with Tuscan pilasters and entablature, with a distinctive grid of boards. This trim is also found on the west elevation at the rear on the single-story projecting square bay that wraps around to the rear of the house. The front portion of this elevation has a distinctive three-part window trimmed with mutules and guttae. There is also a polygonal bay window on the east elevation toward the rear of the building. The house has an asphalt shingle roof, and a chimney exits the house to the west of the ridgeline, towards the rear of the house. The building is centered at the front of the lot, and a driveway provides access to a sided gable-roofed garage at the rear of the lot on the west side of the property.

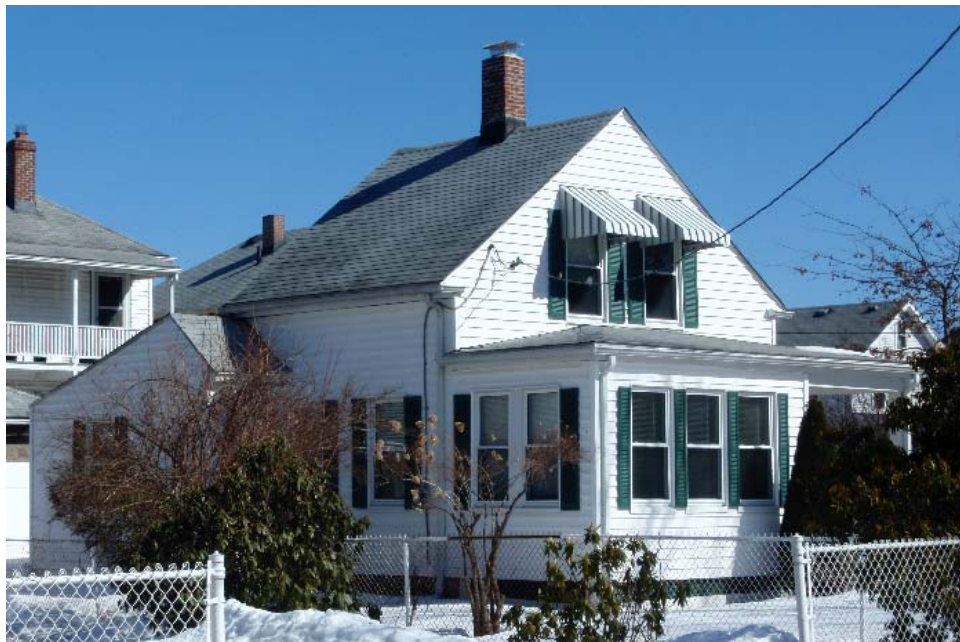
43 Cotting Street, possibly the former Hillside train station

Although it takes the end gabled form, the small and early building at **43 Cotting Street** (1855) is distinct from these neighbors in scale, height, and siting. A *Medford Historical Register* article describing the development of Hillside notes that the original train station was moved to Cotting Street and converted to a house: "[w]hen disused, the old station was moved to Auburn Street near the river, and later crowded out by the Parkway to Cotting Street, where it now remains, a dwelling."<sup>1</sup> Based on its small size and unique shape, it is possible that 43 Cotting Street is the moved station. The house sits on the north side of the street, noticeably set back from the street. It is roughly centered on the lot, with a driveway to the east of the house. The house itself appears to be single-pile and is three bays wide with the entrance in the east bay of the main façade. A brick chimney exits the ridgeline at the center of the house. An unusually deep single-story hipped-roof porch covers the front of the house. The section in front of the main entrance is open, while the section to the west is enclosed. The house has a long single-story shed roof ell at the rear that runs across the width of the house, even with the east elevation of the main body, but extending about four feet to the west. On the east elevation, where the ell joins the main house, is an enclosed gabled projecting entryway. The house has a brick foundation, vinyl siding, and an asphalt shingle roof. The windows are modern one-over-one sash with vinyl shutters, and there are metal awnings over the two windows in the street-side gable end.
