Thomas Brooks Park Archaeological Protection Concept Design

City of Medford Historical Commission October 22, 2024

Public Meeting

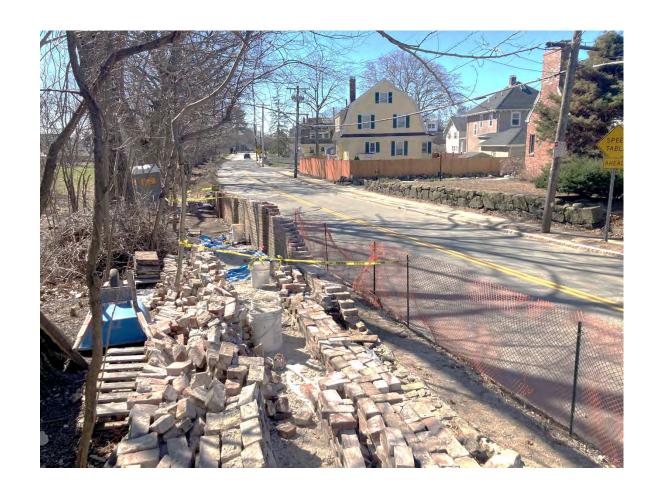
2019 Wall Condition

• Previous joint condition

• Cap stone repair needed

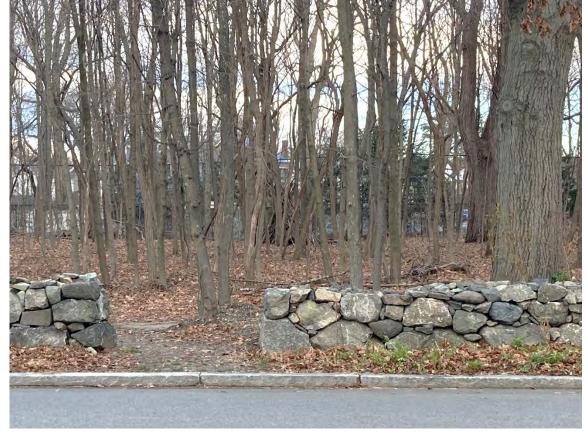
2019 Grove Street Edge Condition

• Field stone wall in need of repair

Clear understory behind wall to provide some visibility into the park

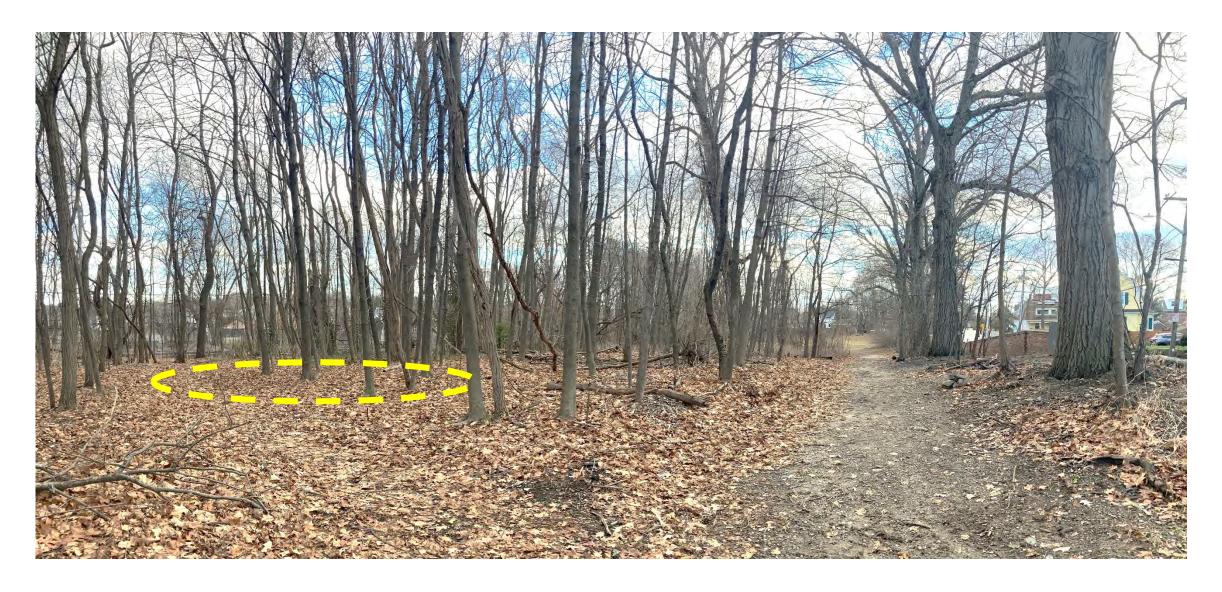
Recommendations from 2023 Archaeological Survey Technical Report:

- PAL recommends site protection and preservation measures
- Site protection and preservation measures recommended for the high sensitivity area in and around the house site
- In these archaeologically sensitive areas, belowground disturbances should be avoided and /or kept at a minimum

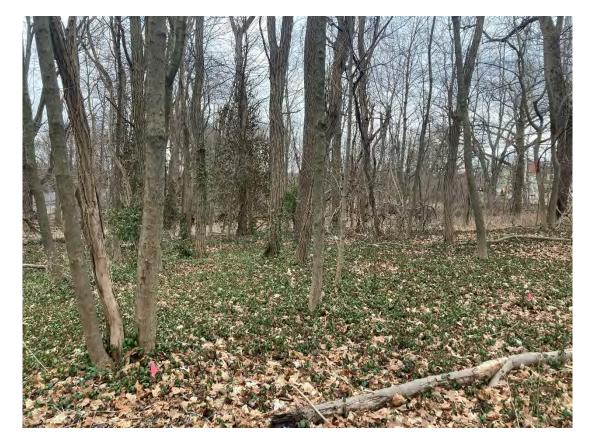
Approximate house location

Looking south

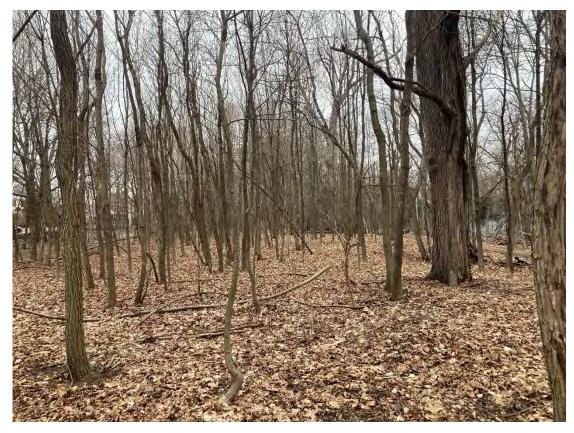
Looking north

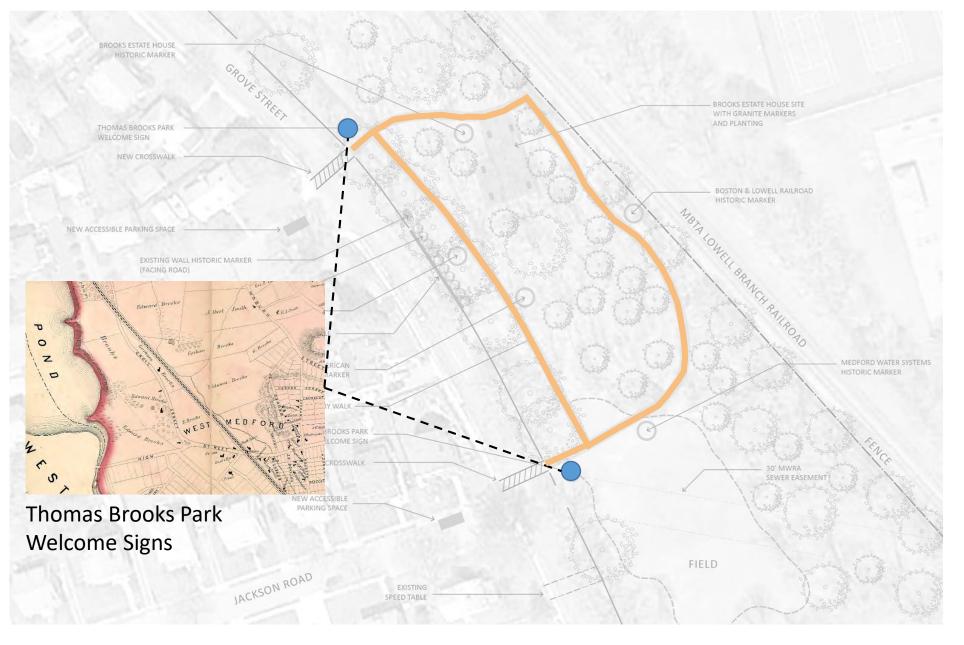
History Walk

- Accessible path for slope and surfacing
- Connected to new crosswalks

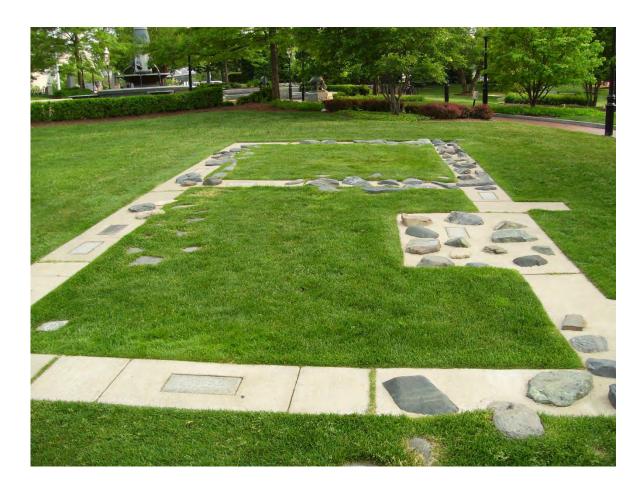
Trace of foundation for Governor Winthrop House

Great House Site, Charlestown, MA

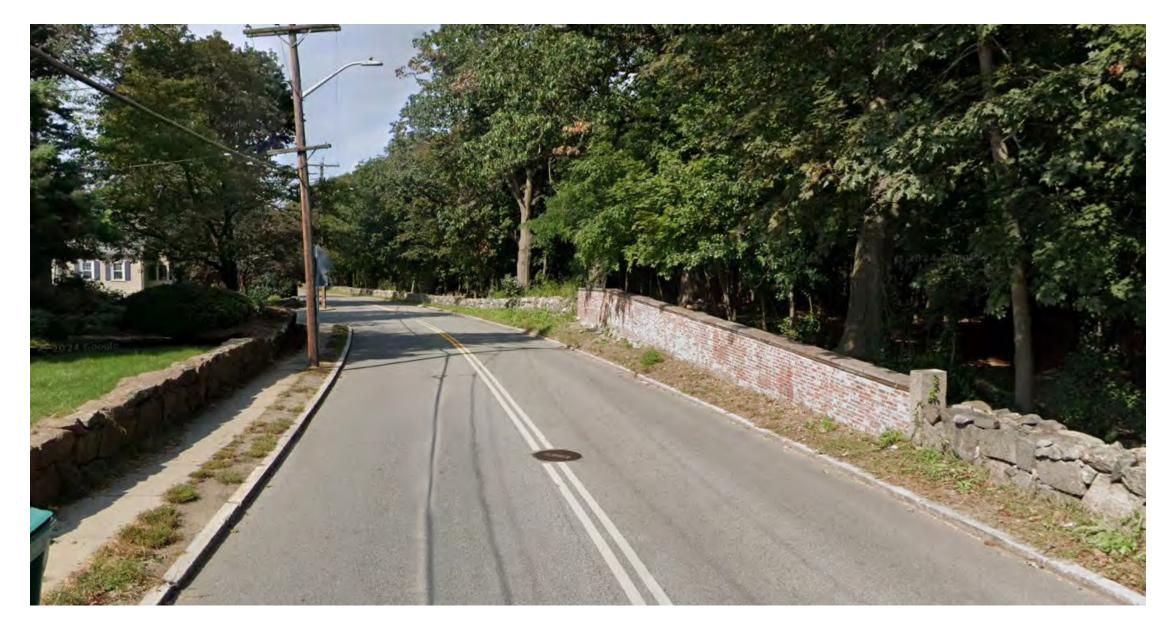
Existing Conditions – Pomp's Wall from Grove Street

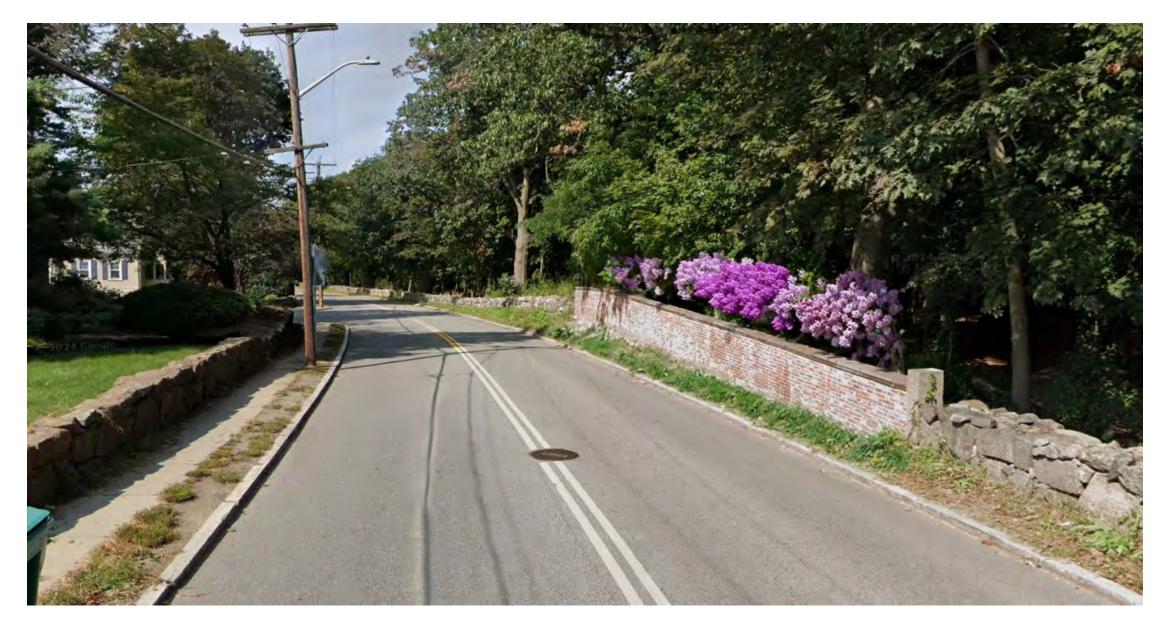
Proposed lilacs behind Pomp's Wall

- Part of New England's horticultural heritage
- "Beside the street and between the ends of the drive was this brick wall constructed, and bordered with a row of lilacs."

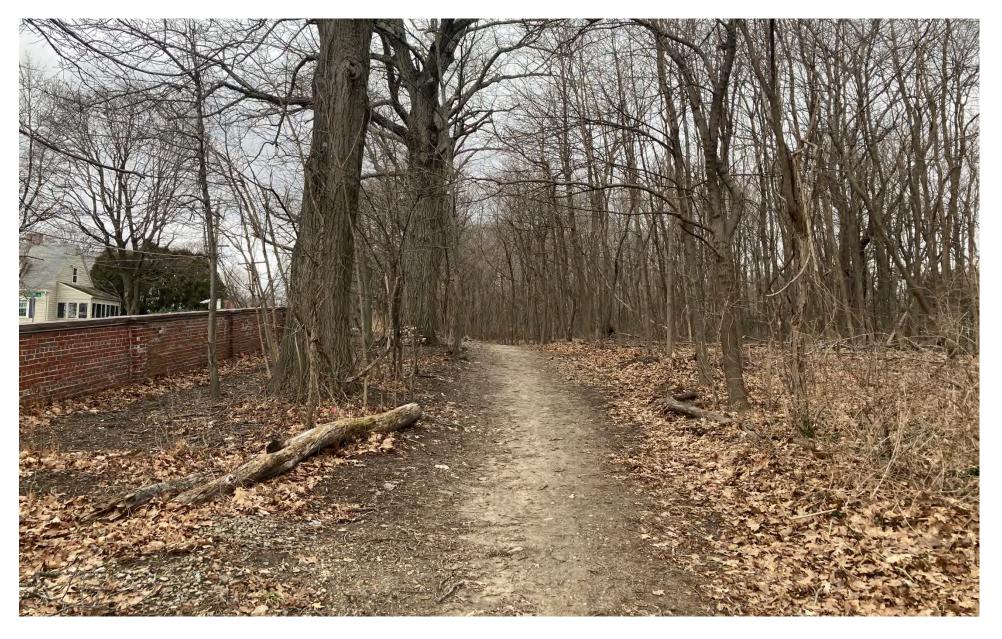
Existing Conditions – walk behind Pomp's Wall
