FANNIN • LEHNER

PRESERVATION CONSULTANTS

## REPORT OF TEST EXCAVATIONS IN CROSS STREET CEMETERY, MEDFORD MA TO DETERMINE BELOW GRADE METHODS USED TO ERECT RELOCATED GRAVESTONES AND MONUMENTS.

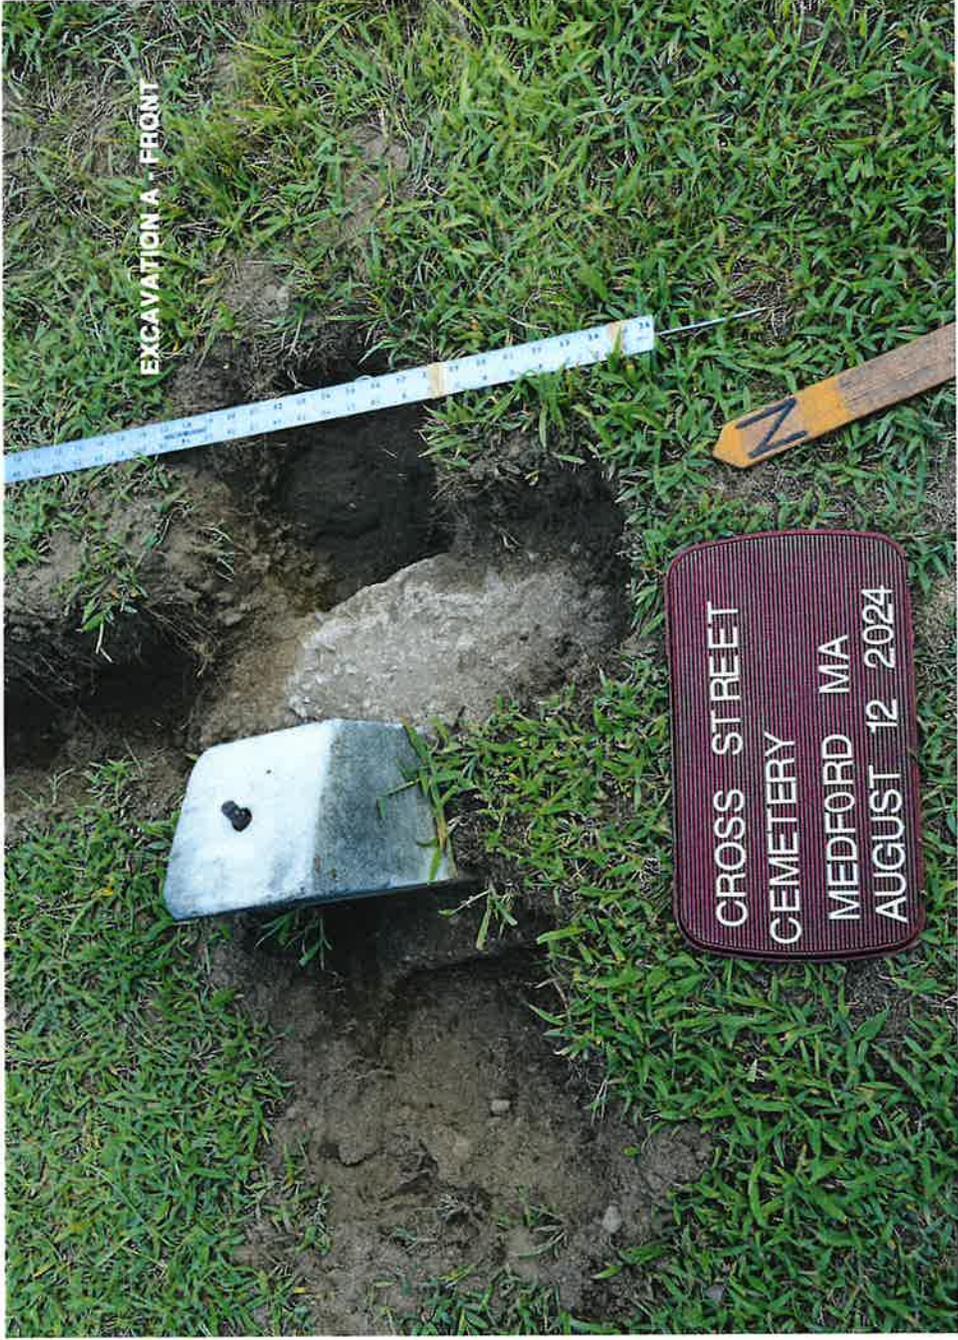
EXCAVATION A - FRONT

- Excavation A – Row 11 – A marble shaft that once held an oval marble marker which is no longer extant. There is a concrete foundation in which the shaft is held. The concrete is 5” +/- below grade. It measures 15” wide, 50” long and 10” +/- deep. The 5”X5” shaft is set with 6” of concrete in front and 3”+ of concrete in back.

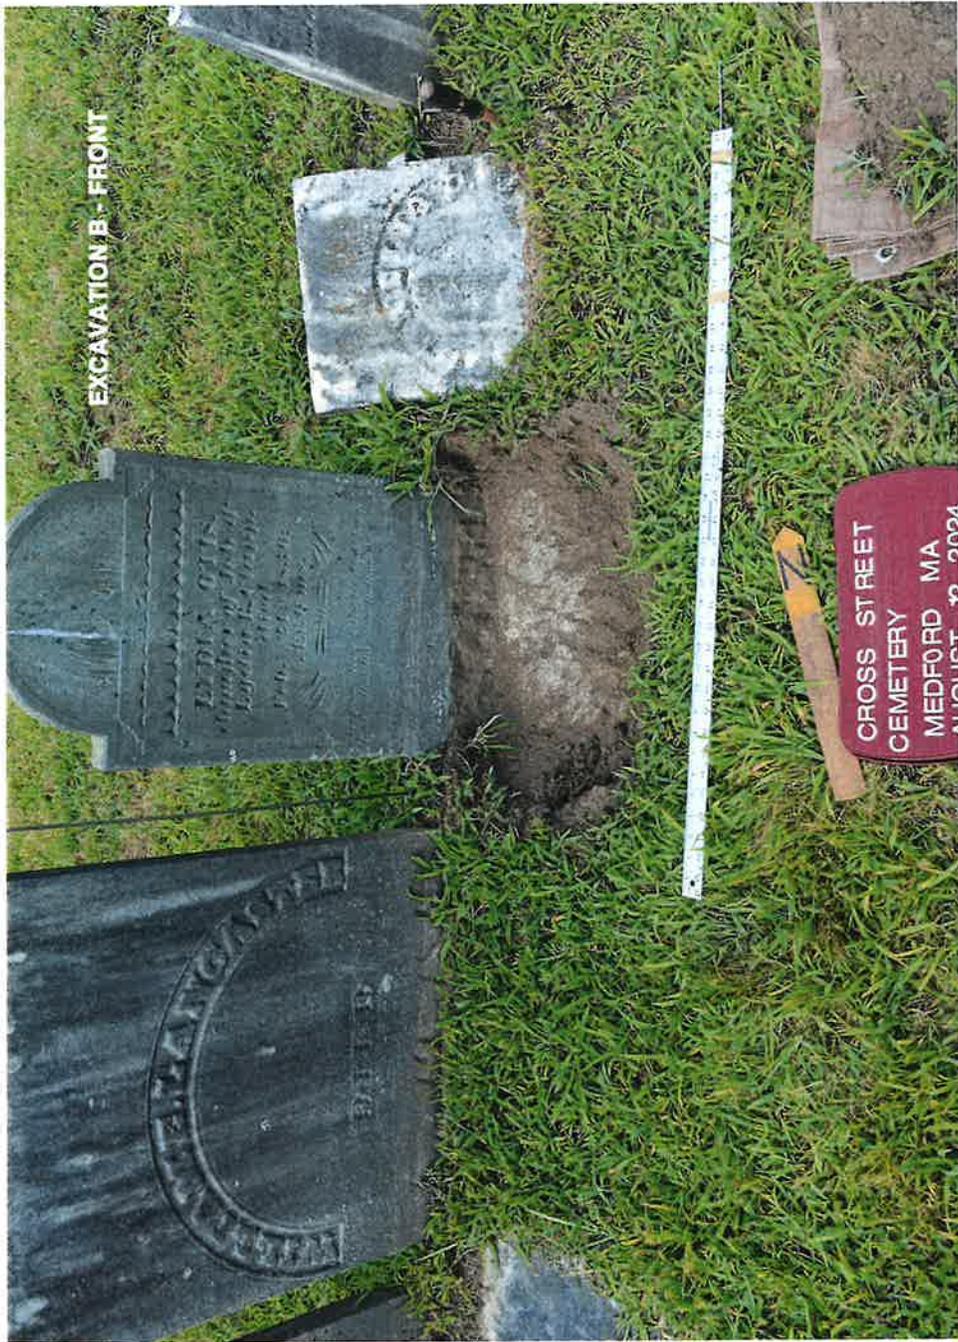
EXCAVATION B - FRONT

- Excavation B – Row 10 – Intact slate headstone, #326 – Lydia Otis Clapp. Stone is set in a continuous concrete foundation running from the first stone in the row to the central walkway. Foundation extends 9” in front, 7” in back with a depth of 10”+/-.

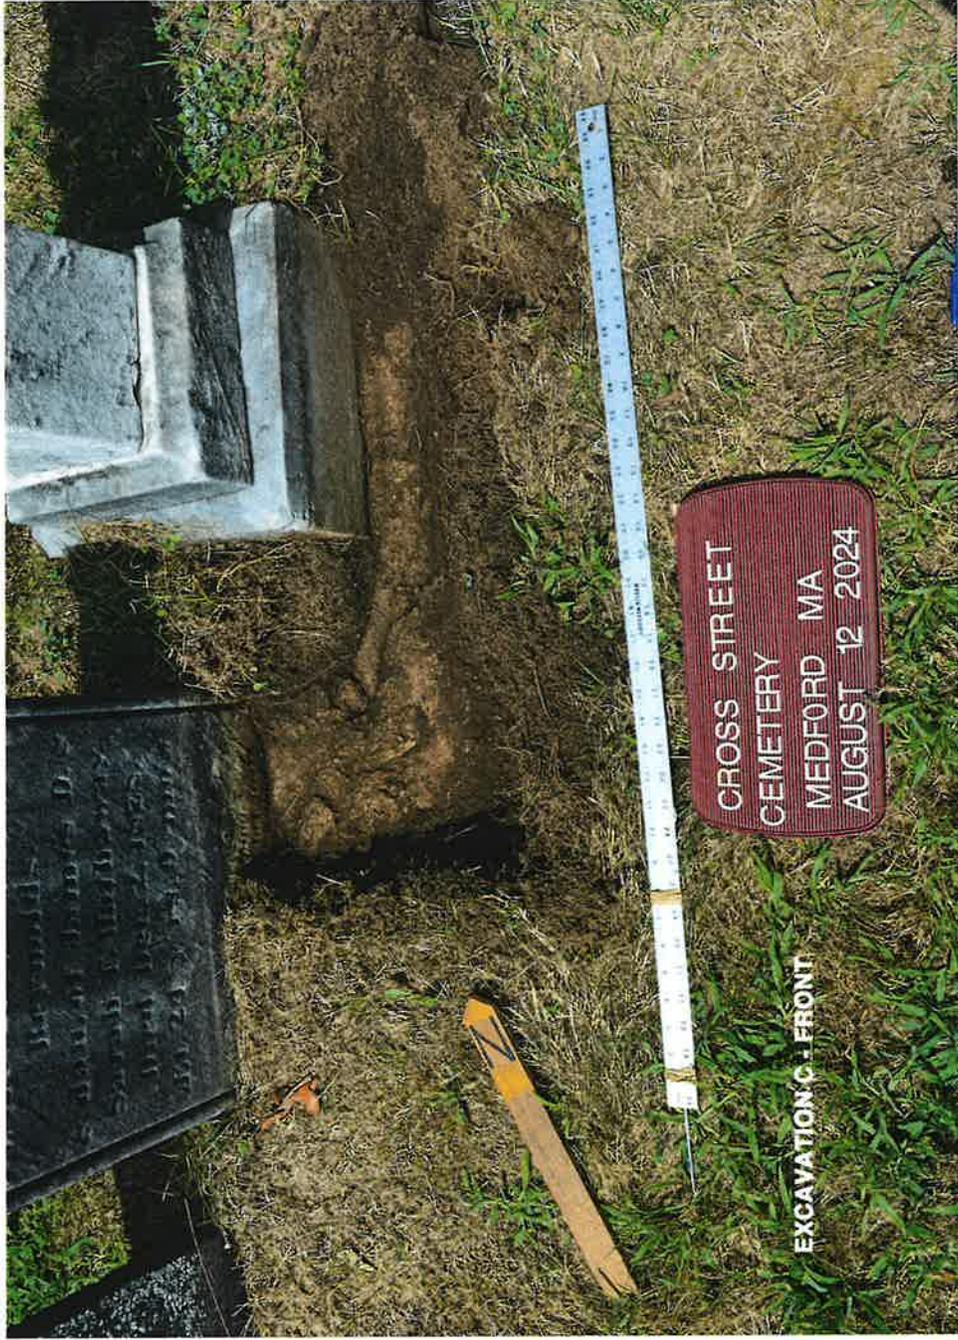
EXCAVATION C - FRONT

- Excavation C – Row 7 – Small marble obelisk, #238 – Roland H. Hathaway. Base of obelisk firmly attached to a concrete foundation, 27” wide, clearly placed there when concrete was wet. Foundation extends 10” from front of base and 3” from back. This wide section of the foundation is part of a narrower continuous one holding headstones in Row 7 on the south section of the row.

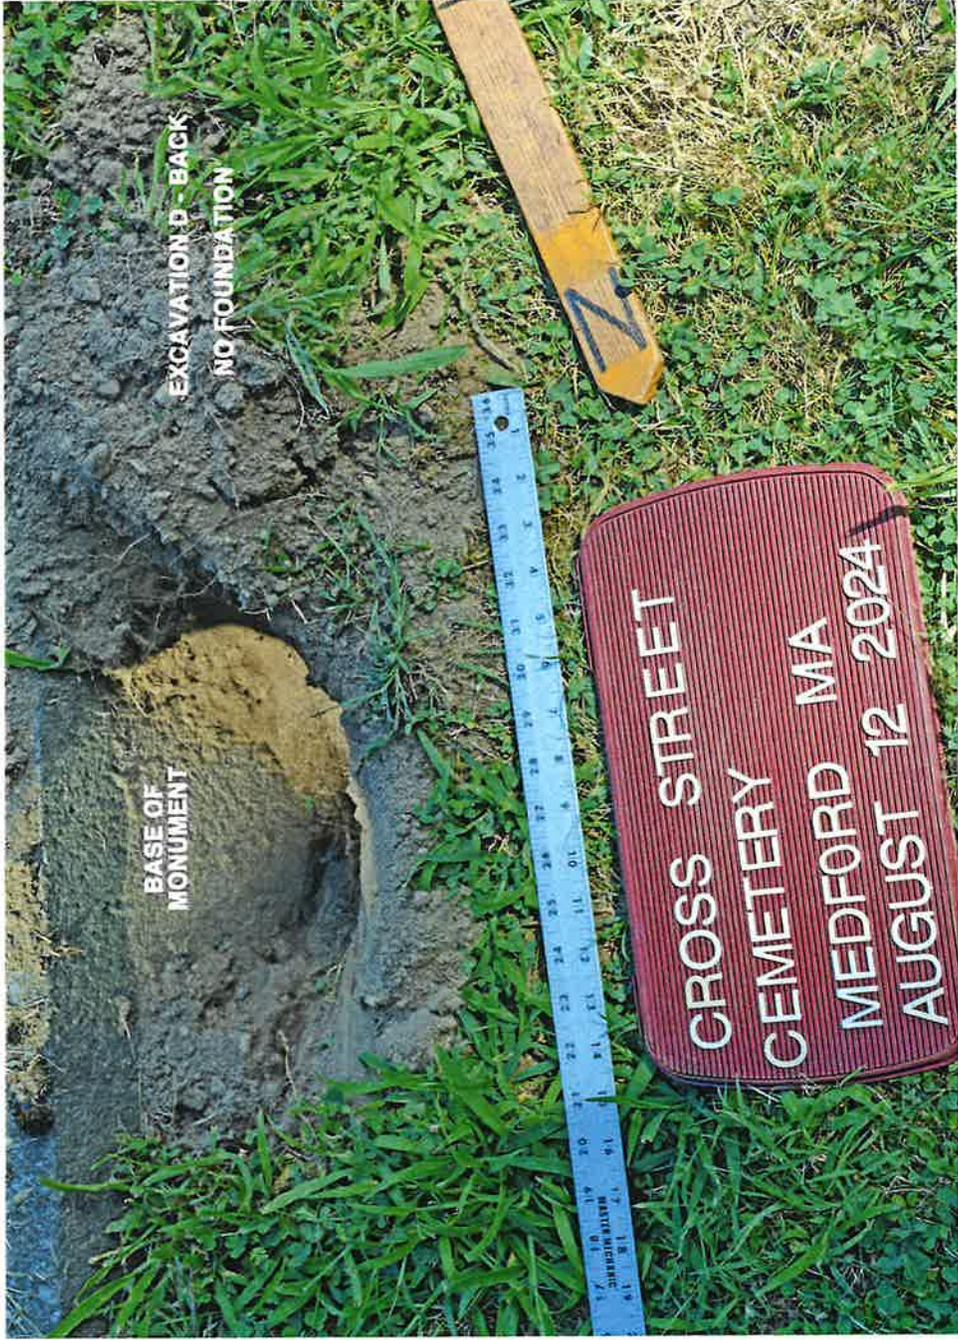
EXCAVATION D - BACK  
NO FOUNDATION

- Excavation D – Row 5 – Marble monument with marble mid-base and granite lower base, #169 – John McRae, Catherine McRae – tilted. Excavated to a depth of 8” plus extensive probing. No concrete foundation located.

BASE OF  
MONUMENT

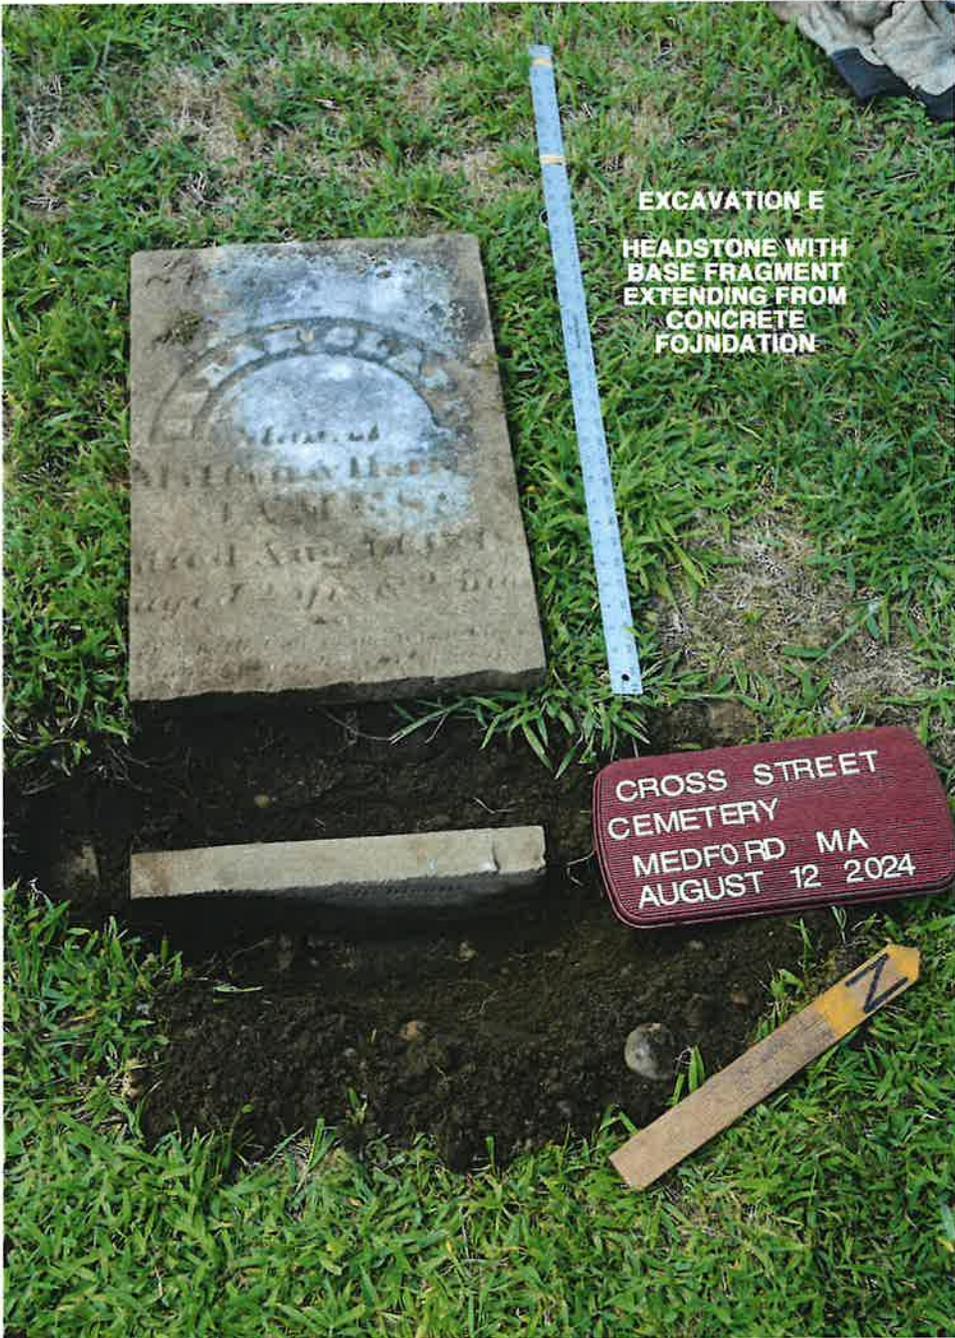
EXCAVATION E

- Excavation E – Row 3 – Marble headstone, #71 – Sarah Clapp James. Broken and fallen. Excavated and uncovered bottom fragment in concrete foundation which runs the length of the southern section of the row. Bottom fragment brushed clean and a test fit performed to see if top fragment conformed to the top of the bottom fragment. Top fragment fit perfectly on the fragment held in concrete.

HEADSTONE WITH  
BASE FRAGMENT  
EXTENDING FROM  
CONCRETE  
FOUNDATION
